**Title:** Flat Panel Display Unit and Method of Repairing...

**Atty Docket No. 16869P-031900**

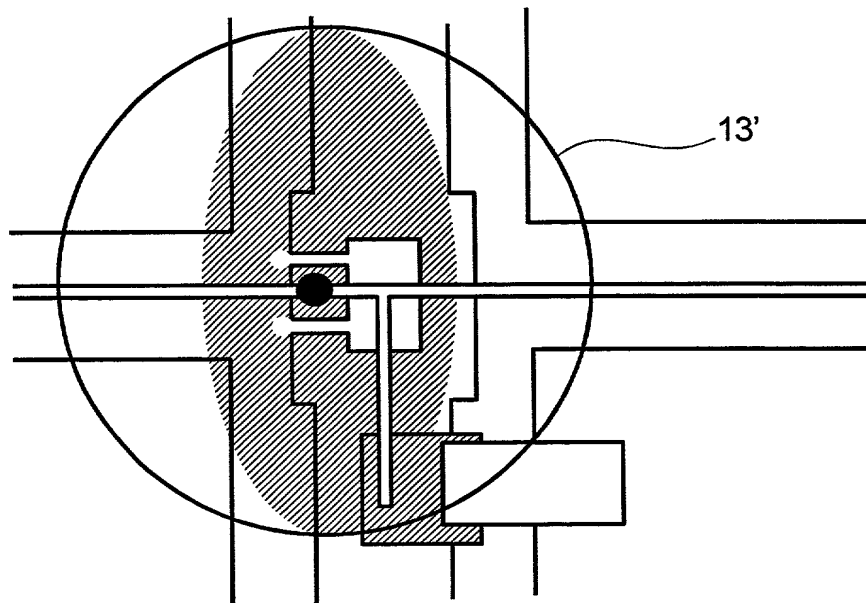
**FIG.2**

12 : Glass pipette

13 : Insulating film material

13' : Insulating film material coating range

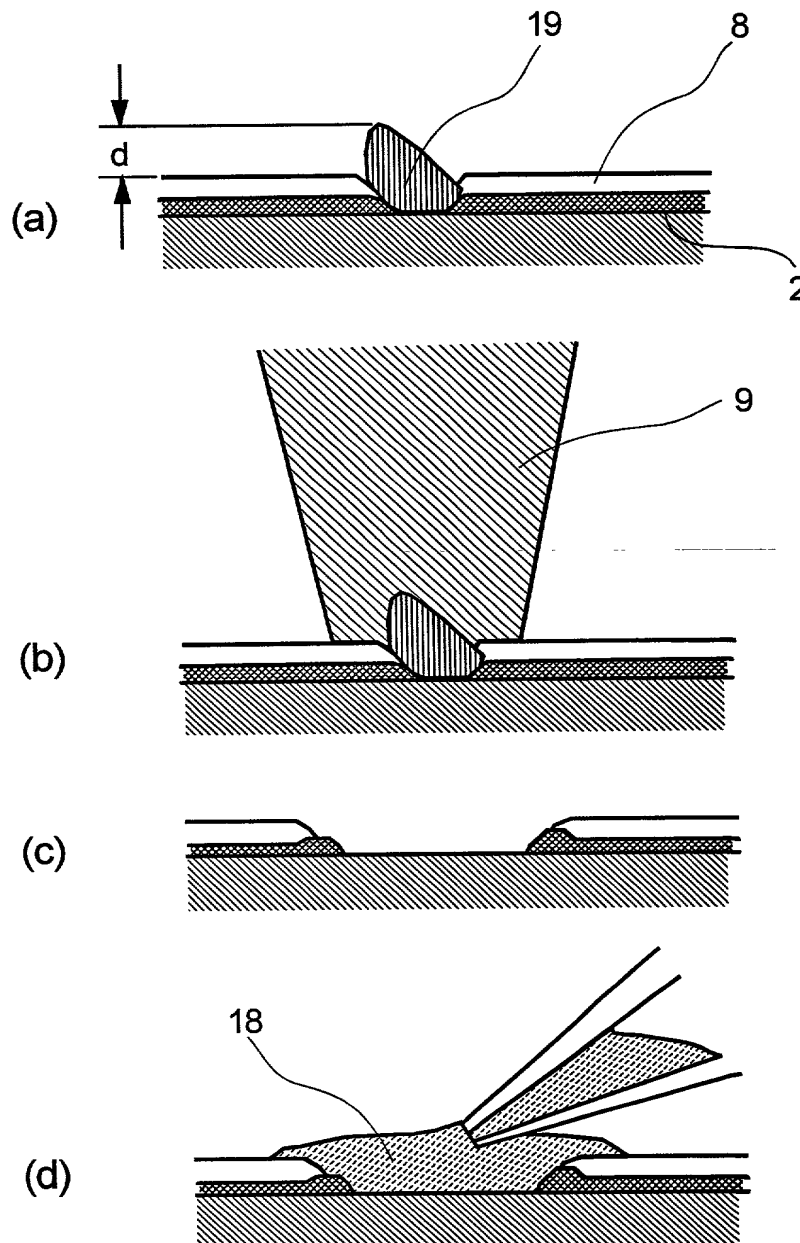
FIG.7

19 : Foreign object

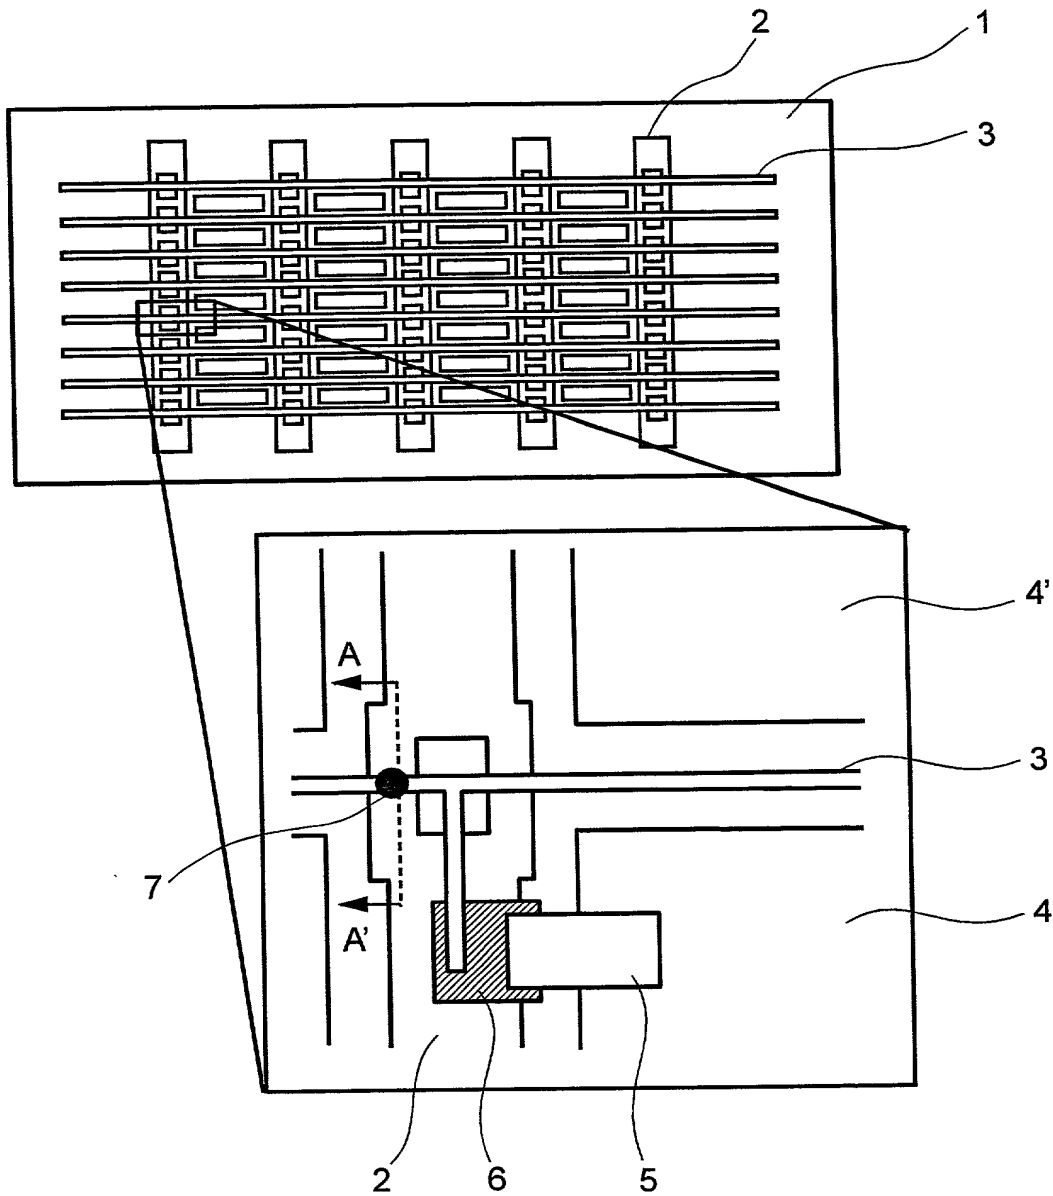
FIG.8

- 1 : Glass substrate
- 2 : Scan line
- 3 : Signal line
- 4 : Pixel
- 6 : TFT structure
- 7 : Shorting defect portion

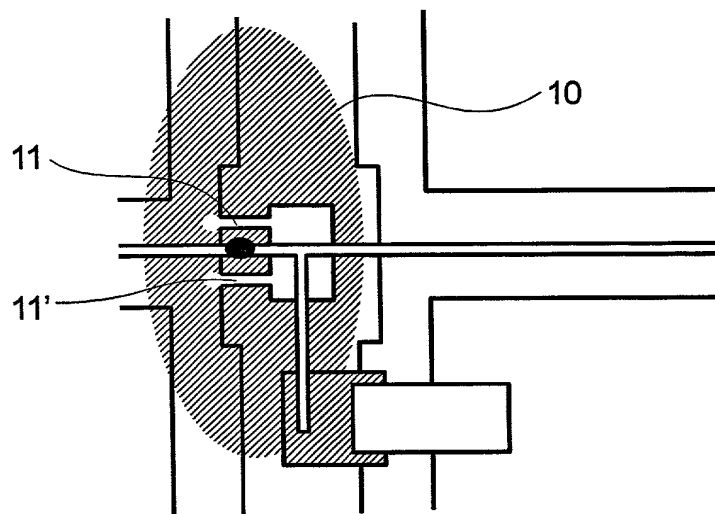
FIG.10

8 : Inter-layer insulating film

9 : Laser

10 : Dispersed metal

11, 11' : Portion severed by laser
